Five-Year Review Report

First Five-Year Review Report for the Vandale Junkyard Superfund Site Washington County, Ohio

April 2004

**United States Environmental Protection Agency
Region 5
Chicago, Illinois**

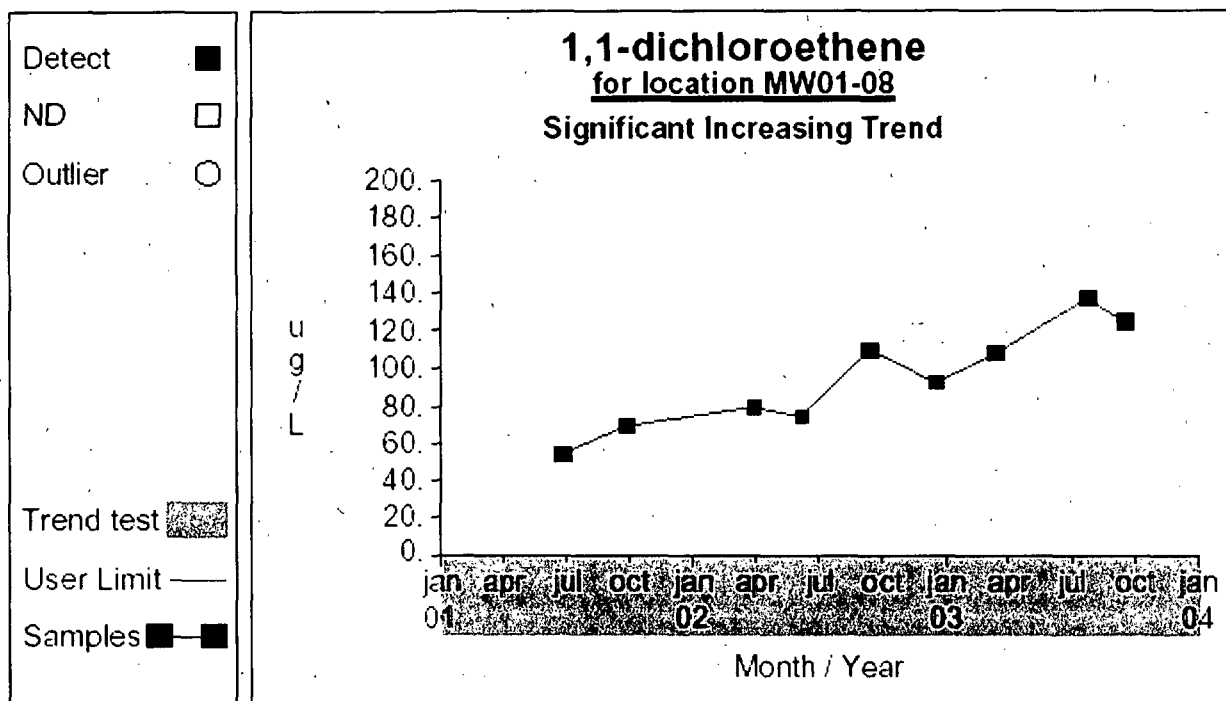
Figure 25

Overall, the quarterly monitoring appears to indicate steady-state conditions with regard to VOC levels in the groundwater over the recent past. At MW01-08, there is a statistically significant increasing trend for 1,1 DCE. This is the only statistically significant increasing trend identified by the trend analysis. In most cases, there is no clearly apparent increase or decrease in VOC concentrations since the quarterly monitoring began in 2001.

The contaminant that had an increasing trend was 1,1,-dichloroethene; this was at only one location, MW01-08. The most recent sample of 1,1,-dichloroethene at MW01-08 statistically exceeded previous sampling concentrations as well. These observations may indicate that contamination is becoming worse at this location. However, the presence of 1,1 DCE is most likely due to the degradation of 1,1,1-TCA, and the increase in a daughter product (1,1, DCE) may not indicate that natural attenuation is not functioning according to expectations.
